1978-1988 GM G-Body Tubular Frame Brace/Control Arm Reinforcements Item # 3028

Item # 3028

78-88 GM G-Body Control arm reinforcement

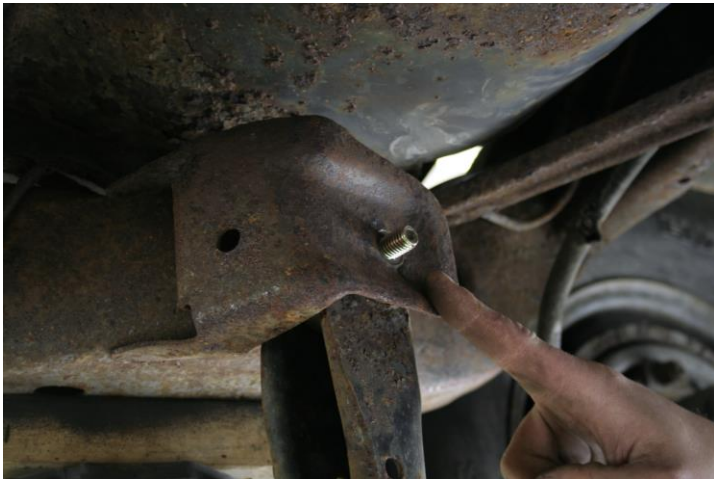
When installing new bolts only let the bolt stick out 1", install the brace.

6. Now install new longer supplied bolt into the lower control arm mount. Only let partial threads stick out at this time. (See image 1)
7. Locate new frame brace and install it on the upper bolt first and attempt to install it on the lower, the adjustment end will install closer to the lower control arm bolt. Lengthen or shorten the frame brace as needed to install it on both bolts. (See image 2 for frame brace install position)

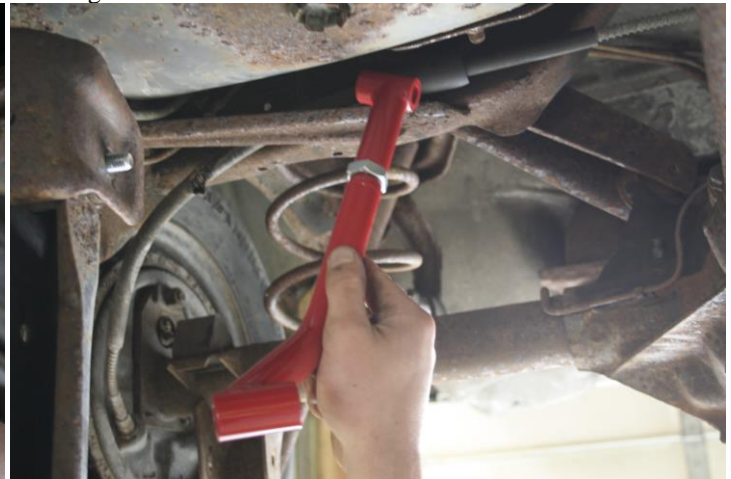
Assemble brace as show with adjusting nut towards the upper control arm. Passenger side shown.

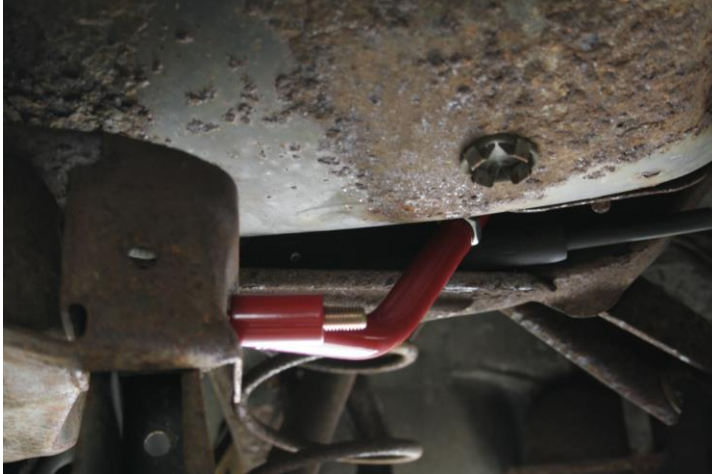
Passenger side brace installed.

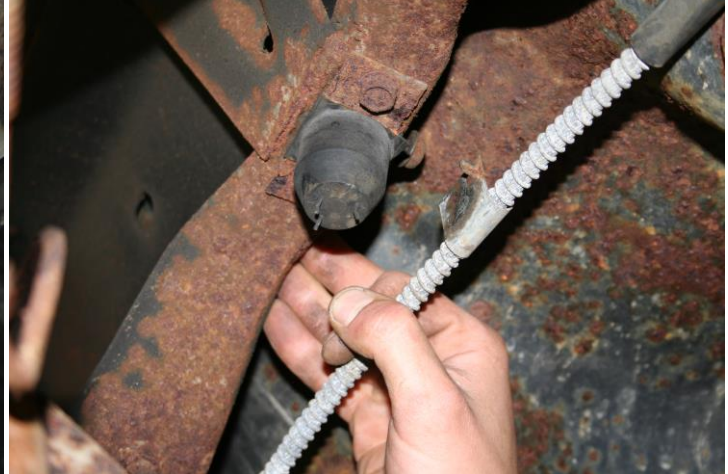
E-brake cable above rear end bump stop may need loosened.
